SLOPE STABILITY ASSESSMENT WITHIN AND AROUND THE RESERVOIR OF THE PROPOSED BASARA DAM, SULAIMANIYAH, NE IRAQ

Ghafor A. Hamasur¹

ABSTRACT

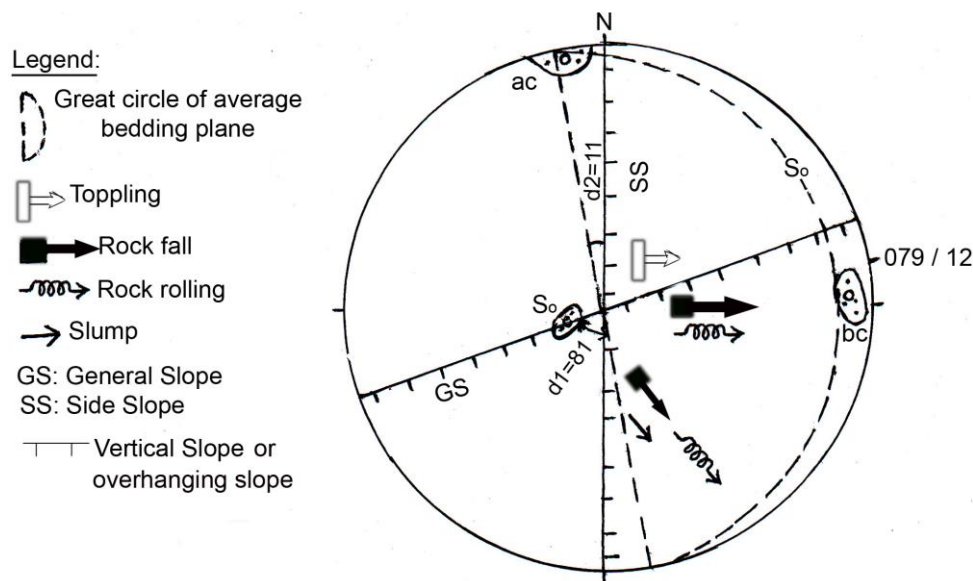
— **Station No. 1:** It is located at the right bank near the proposed dam (Fig.2), at elevation of 940 m (a.s.l.), and at a height of 210 m above the water level; when the reservoir is filled. There are two slopes in this station, the general slope inclination is $160^{\circ}/90^{\circ}$ and that of the side slope is $090^{\circ}/90^{\circ}$. The bedding planes are dipping with an average value of $079^{\circ}/12^{\circ}$. Therefore, the general slope is orthogonal (divergence angle $d1 = 81^{\circ}$), left emergent and discordant slope, while the side slope is a daylight, parallel ($d2 = 11^{\circ}$), left emergent and concordant (Figs.3 and 4). The rocks of the the Station No. 1 are composed of dolomitic limestone of Pila Spi Formation. The bedding thickness ranges from (0.4 – > 2) m, they are dissected by two sets of joints, they are ac-joint set and bc-joint set (Figs.3 and 4), their spacing ranges from (0.5 – > 3) m, and their persistence is more than 20 m.

Fig.3: Stereographic projection shows the relationship between the slope, discontinuities and type of failure, in the Station No. 1

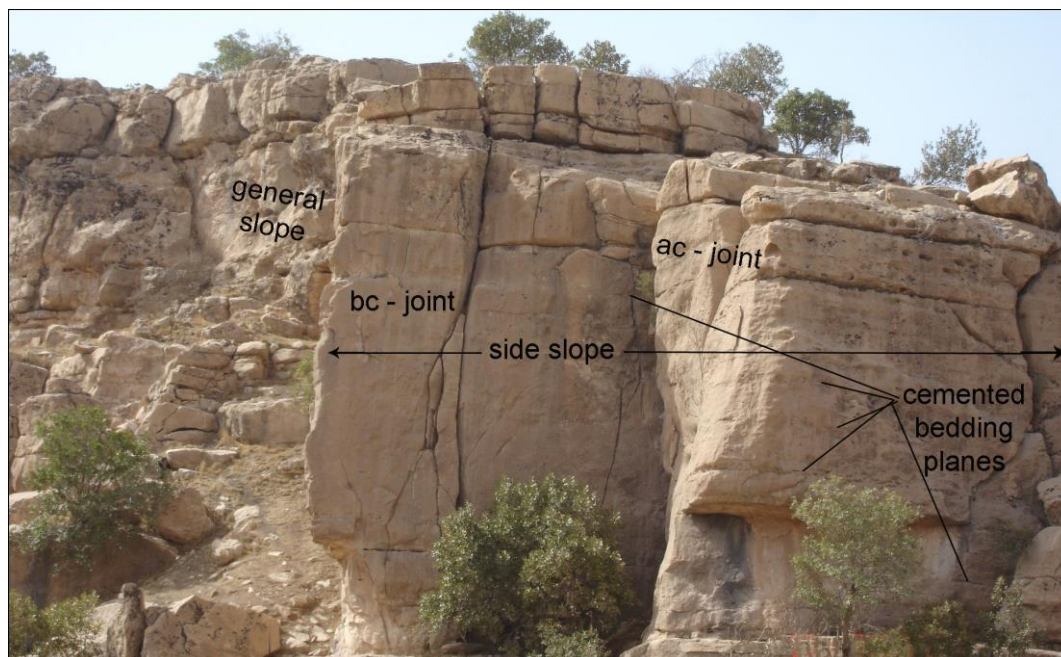
Fig.4: Unstable vertical slopes in the Station No. 1 within the Pila Spi Formation
(The trees are about 4 – 6 m in height) (Photo direction is westwards)

The side slope ($090^{\circ}/90^{\circ}$) is unstable, wherein rock fall and toppling have occurred. Because the bedding planes below the upper part of the vertical slope are well cemented (having high cohesion), therefore, the effective spacing, which depends on the length of discontinuities and the size of the intact rock within a block that actually influences the height (h) or width (b) of the block of the bedding plane. Accordingly, leads to form high blocks up to 20 m in height and (2 – 3) m in width (Fig.4). The blocks are resting at an angle of 12° on the basal plane (bedding plane here), the ratio of $b/h = 2.5 \text{ m} / 20 \text{ m} < \tan 12^{\circ}$ ($0.125 < 0.212$). This leads to the weight vector of rock blocks to fall outside their base (Fig.5), then they are liable for toppling; when the cohesion on all discontinuities becomes zero, even blocks of less than 20 m in height may be subjected to secondary toppling by mechanism of failure by horizontal stress in σ_3 direction (perpendicular to free face) as mentioned by Evans (1981).

The general slope ($160^\circ/90^\circ$) is also unstable, wherein the rock falls and secondary toppling (due to mechanism of failure by undercutting of dolomitic limestone beds below basal plane) have occurred, also due to the steepness of the slope further blocks fall and topple and they may be roll on the slope, then some blocks may reach the Basara stream.

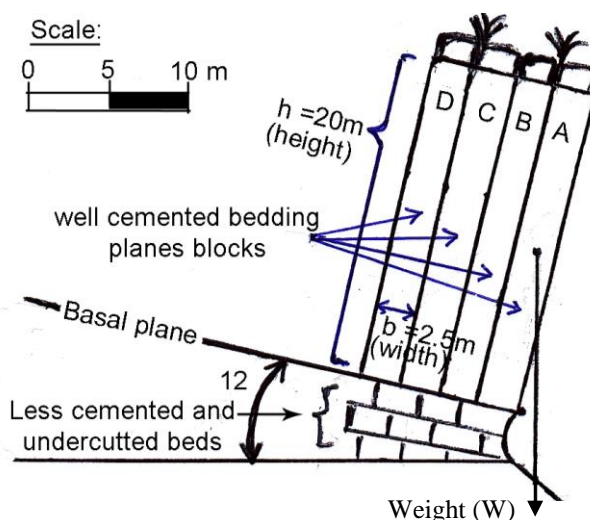
Fig.5: Geometry of rock blocks on inclined bedding plane (basal plane)
at an angle 12° at the side slope in the Station No. 1

During toppling, the bedding planes act as basal plane, bc-joint acts as back release surface and the ac-joint acts as lateral release surface. Plane sliding does not occur because the friction angle of the bedding plane is greater than the bedding plane angle (12°).

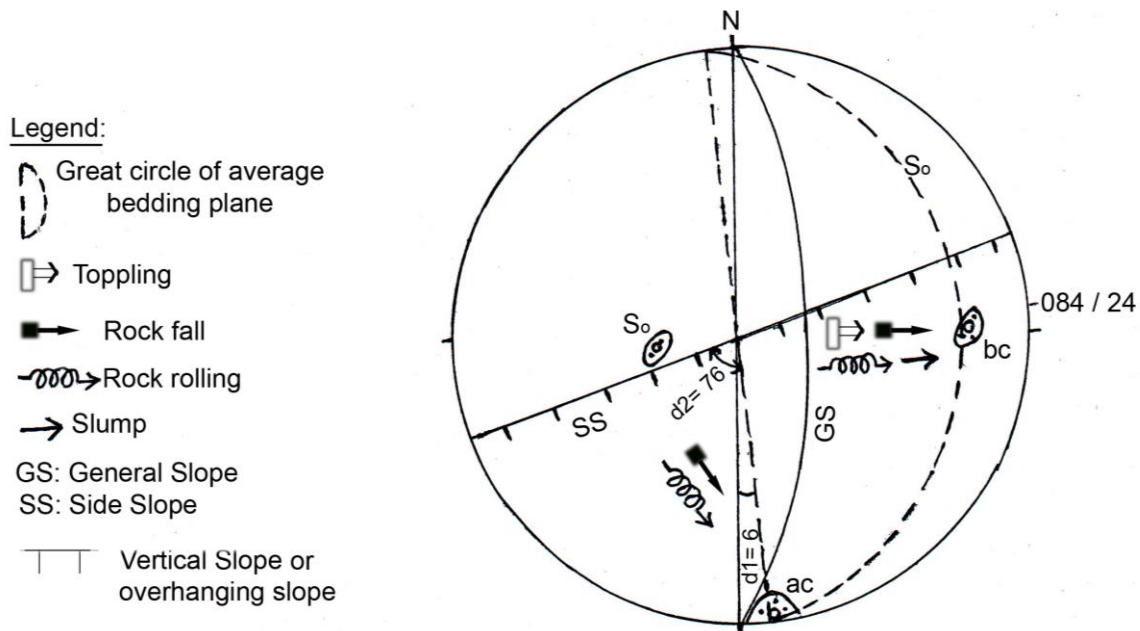
— **Station No.2:** It is located at a distance of 100 m to the east of the Station No. 1 (Fig.2), it has elevation of 895 m (a.s.l.), and a height of 165 m above the water level, when the reservoir is filled. There are two slopes in this station, inclination of the general slope is $090^\circ/70^\circ$, and of the side slope is $160^\circ/90^\circ$. The bedding planes are dipping with an average of $084^\circ/24^\circ$. Therefore, the general slope is parallel ($d1 = 6^\circ$), left emergent and concordant, while the side slope is orthogonal ($d2 = 76^\circ$), left emergent and discordant (Fig.6).

The rocks of the Station No. 2 are composed of dolomitic limestone of Pila Spi Formation. The bedding thickness ranges from (0.4 – > 2) m, they are dissected by two sets of joints, they are ac-joint set and bc-joint set (Fig.6), their spacing ranges from (0.5 – 2.5) m, and their persistence is more than 10 m, especially of bc-joint set.

Fig.6: Stereographic projection shows the relation between the slopes, Discontinuities and type of failure in the Station No. 2

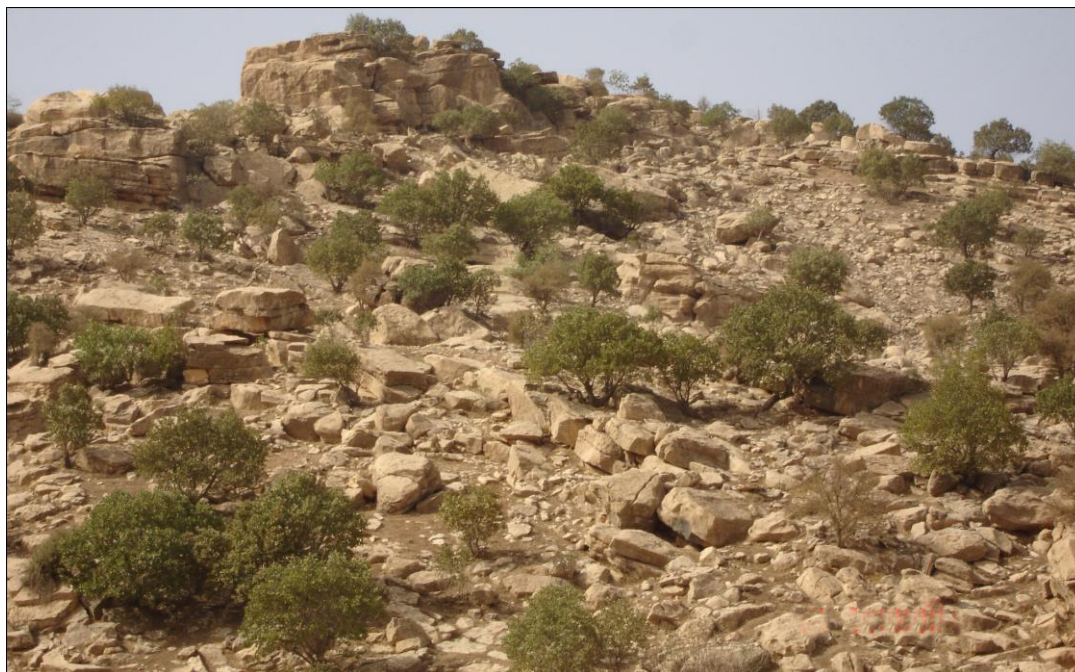
The two slopes in the Station No. 2 are unstable, many previous failures (toppling, rock fall, rock rolling and slumping) have occurred (Fig.7). The height of the upper steep part of the general slope ($090^{\circ}/70^{\circ}$) is about 10 m, and the lower part is inclined at angle ranges from ($35^{\circ} - 40^{\circ}$). The height of the upper part of the vertical side slope is more than 20 m (Fig.8). Some of the bedding planes are very tight (having high cohesion), this leads the effective spacing of the bedding to form blocks of about (5 – 7) m height and (0.5 – 2.5) m width (Fig.9), and they are resting on the basal plane (bedding plane) at an angle of 24° (Fig.10).

Fig.7: Fallen blocks on the general (main) slope at the Station No. 2 (the trees are about 2.5 – 4 m in height) (Photo direction is west wards)

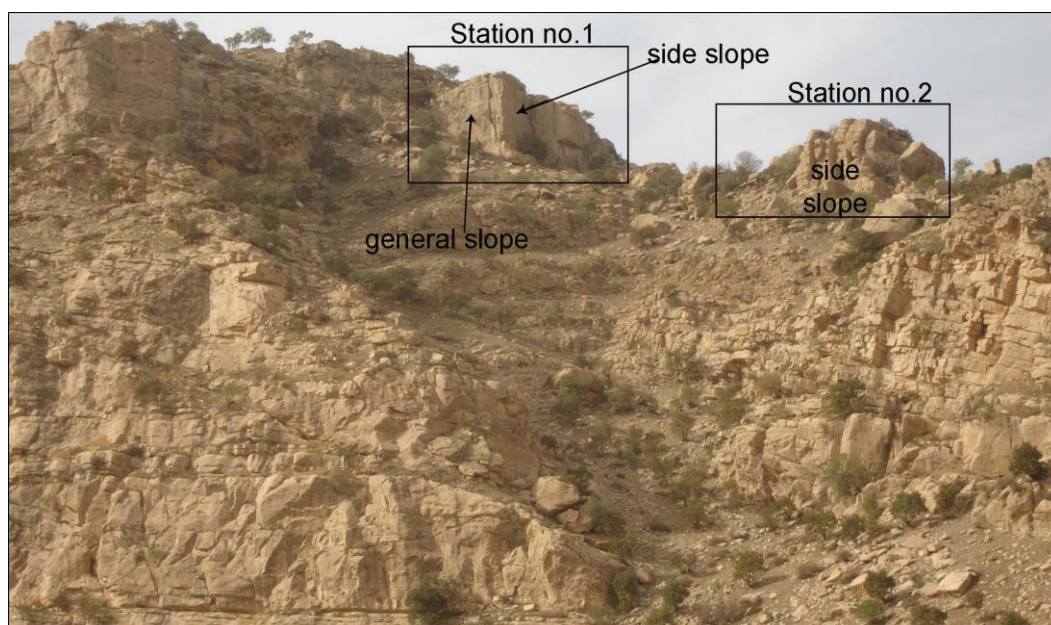
Fig.8: The side slope of the Station No. 2, also the Station No. 1 appears in this photo (Photo direction is 340°)

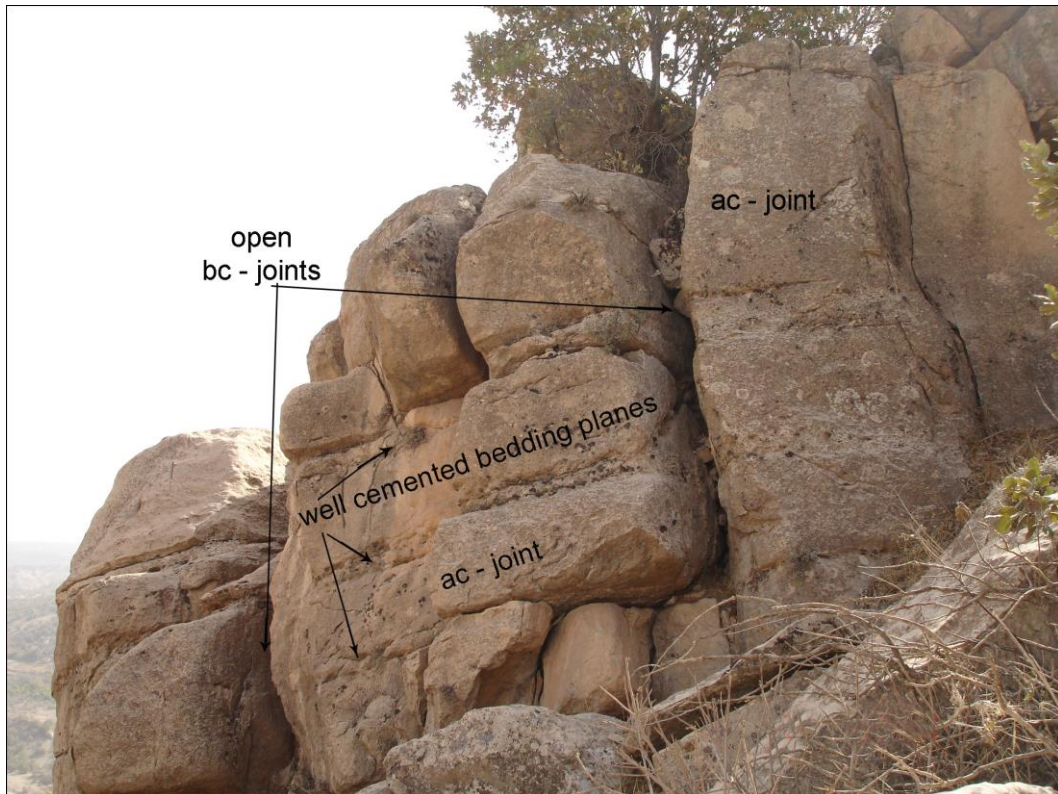
Fig.9: Very tight bedding planes, forming blocks of about (5 – 7) m in height in the Station No. 2 (the trees are about 3 – 4 m in height) (side view photo of the general slope in direction of 150°)

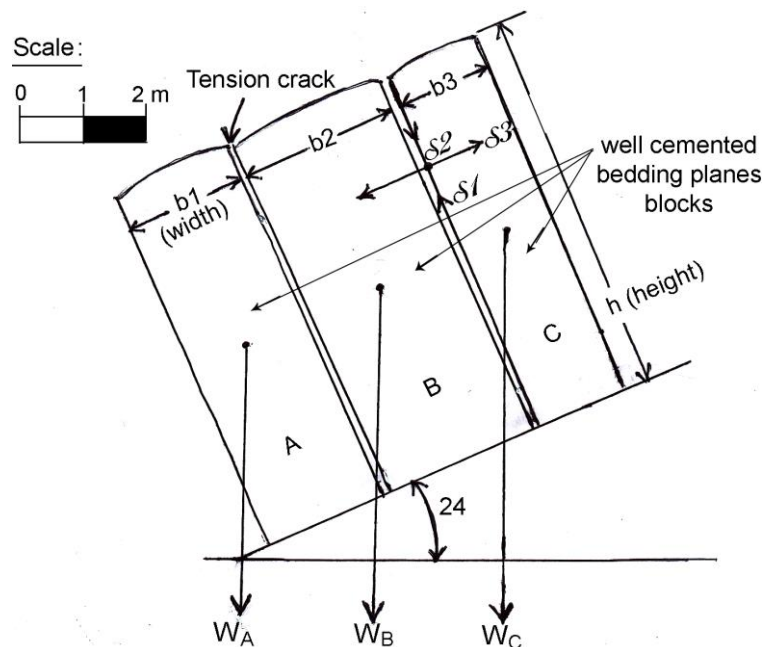
Fig.10: Geometry of rock blocks on inclined bedding plane (basal plane) at an angle 24° at the general slope in the Station No. 2

The weight vector of some rock blocks falls outside their base (b/h of rock blocks $< \tan 24^\circ$) or at critical state (Fig.10), then toppling or secondary toppling (tension crack toppling and slumping) as mentioned by some authors (Goodman and Bray, 1976) may occur in the general slope. The mechanisms involved in such toppling failure are the toppling induced by tension crack water pressure, when filled with water, and failure by horizontal stress in σ_3 direction (perpendicular to the free face) plays a great role (Figs.10 and 11). The joints in the σ_3 direction are invariably (always) open, indicating a fully stress relieved environment in this direction (Evans, 1981). This case is seen for bc-joint set as in Figs. (11 and 12). These states could act with some other primary failure mechanism to initiate toppling. Furthermore, rock fall may occur in the upper part of the slope. After the rock blocks are toppled and the fallen blocks may roll on the lower part of the slope (Fig.7). Rock fall followed by rock rolling is the dominant mode of failure in the side slope due to the steepness of the slope, and toppling failure may occur, but in small number because the basal plane is not inclined in the direction of the side slope. However, plane sliding does not occur in the general slope, because the average bedding plane angle (24°) is less than the friction angle of hard dolomitic limestone, which is more than 35° (Hoek and bray, 1981).

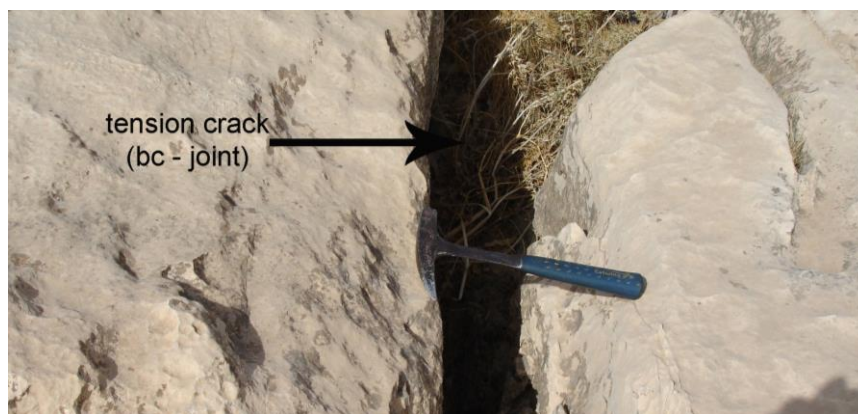
Fig.11: Tension crack represents bc-joint, is an indication of instability in the Station No. 2 (Photo was taken above the bedding plane)

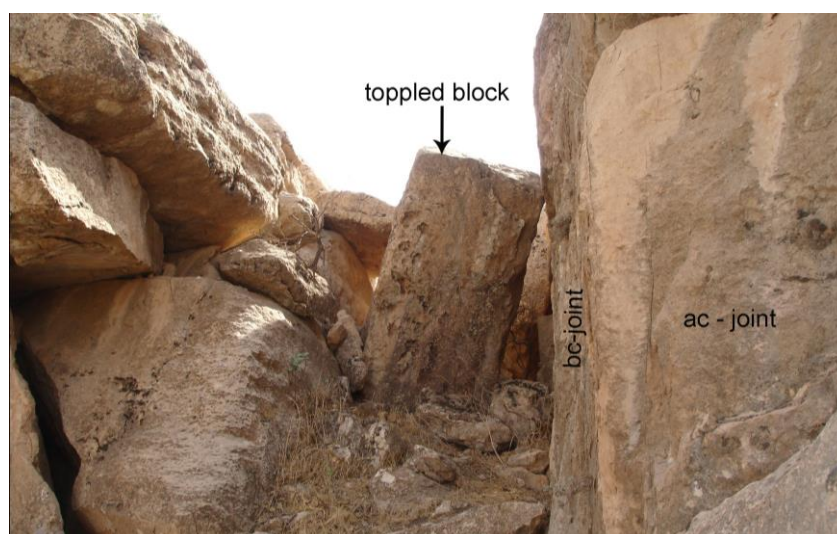
Fig.12: Large tension crack shows opening of bc-joint, ac-joint and toppled block in the Station No. 2 (Photo direction is 170° , parallel to the bc-joint)

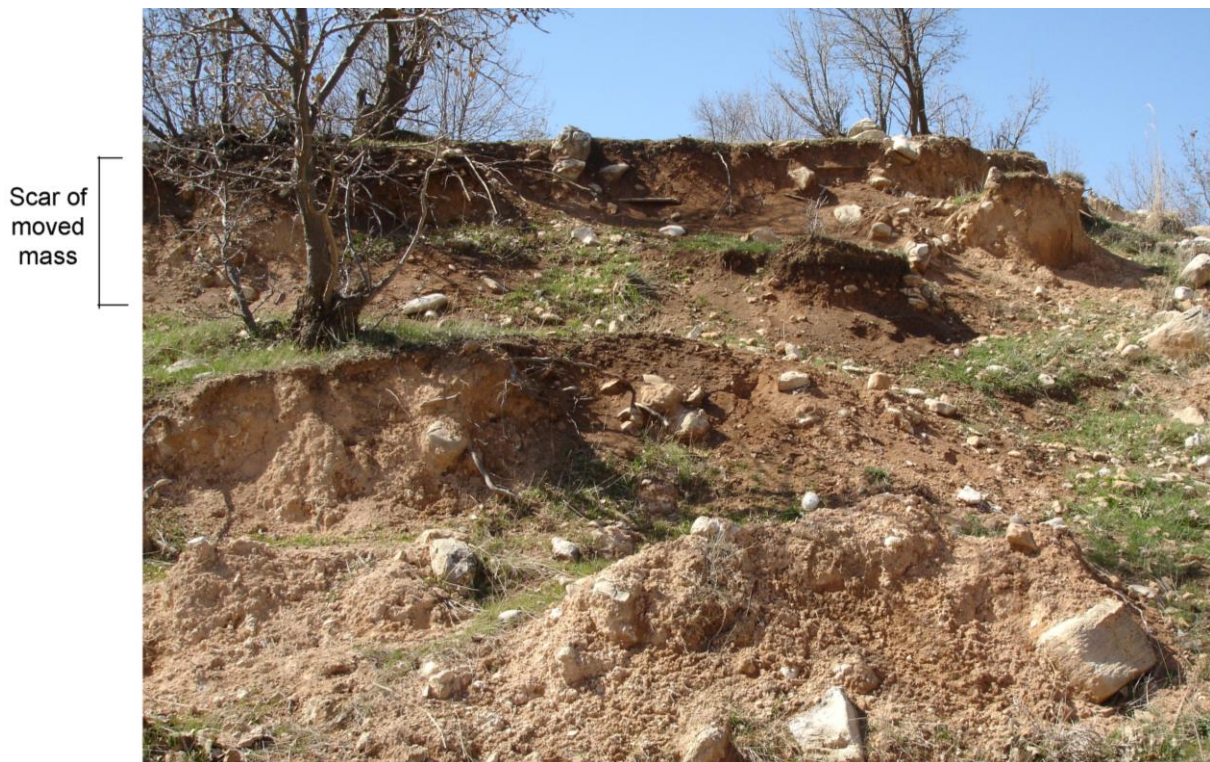
It is located nearby the left bank of Tele stream, to the east of Delaizha village, and at elevation of 715 m (a.s.l.) (Fig.2). The slope is at height of 20 m above Tele stream, and the inclination of the slope is $045^{\circ}/(25 - 30)^{\circ}$. The slope is covered by brown clayey soil with some cobbles and small blocks of limestone. The slope is unstable and was subjected to shallow creep that left a scar in the slope (Fig.13). Such failure, most probably had occurred after heavy rainfall, because normally water causes reduction in the soil friction angle and cohesion and then reduction in the soil shear strength. More creep may occur in the future if torrential rainfall occurs again.

After filling the reservoir of the proposed dam, the Station No. 14 will be inundated, then more creep or slide may occur, and large amount of slope materials will be carried by the water, this will give increase in the rate of sedimentation in the reservoir (siltation).

Fig.13: Soil slump shows the scar of moved mass in the Station No. 14
(Photo direction is 230°)

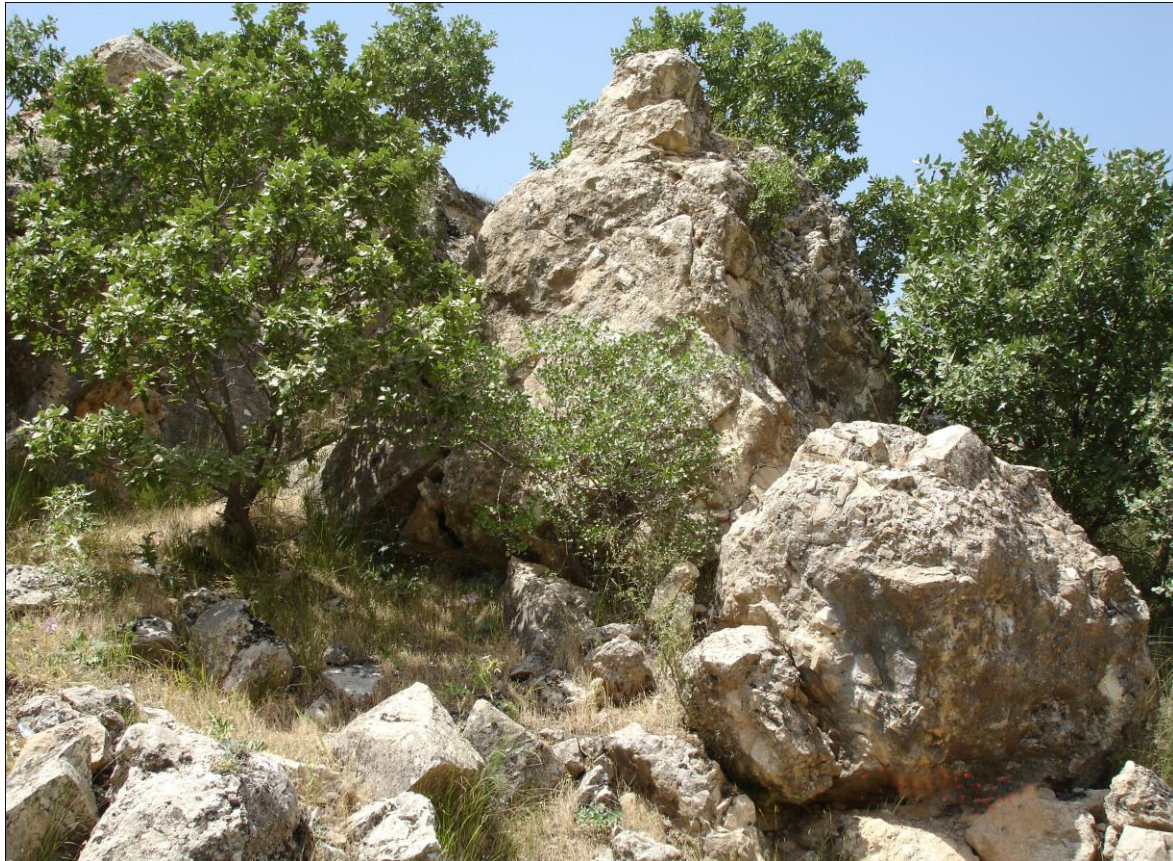
It is located near the converging of Tainal and Tele streams (near the inlet to Darband Basara), on the left bank of Basara stream, and at elevation of 690 m (a.s.l.) (Fig.2). The slope is covered by a mixture of large limestone blocks and clayey soil, silt and sand (Fig.14), fallen from the left cliff of the Pila Spi Formation, and mixed with the weathering products of the underlying Gercus Formation. The slope is unstable, because the toe of the slope has a direct contact with the valley floor and being continuously undercut by water currents during floods, thus the water currents wash out fine materials between the large blocks, and then rolling them to Basara stream valley. Further rolling may take place after filling of the reservoir.

Fig.14: Unstable large blocks of former failures from limestone cliff of the Pila Spi Formation at the Station No. 16 (Photo direction south wards)
