## SITE SELECTION PROBLEMS IN GYPSUM-BEARING FORMATIONS. A CASE STUDY FROM NORTH OF IRAQ

Varoujan K. Sissakian\* and Mawahib F. Abdul-Jabbar\*\*

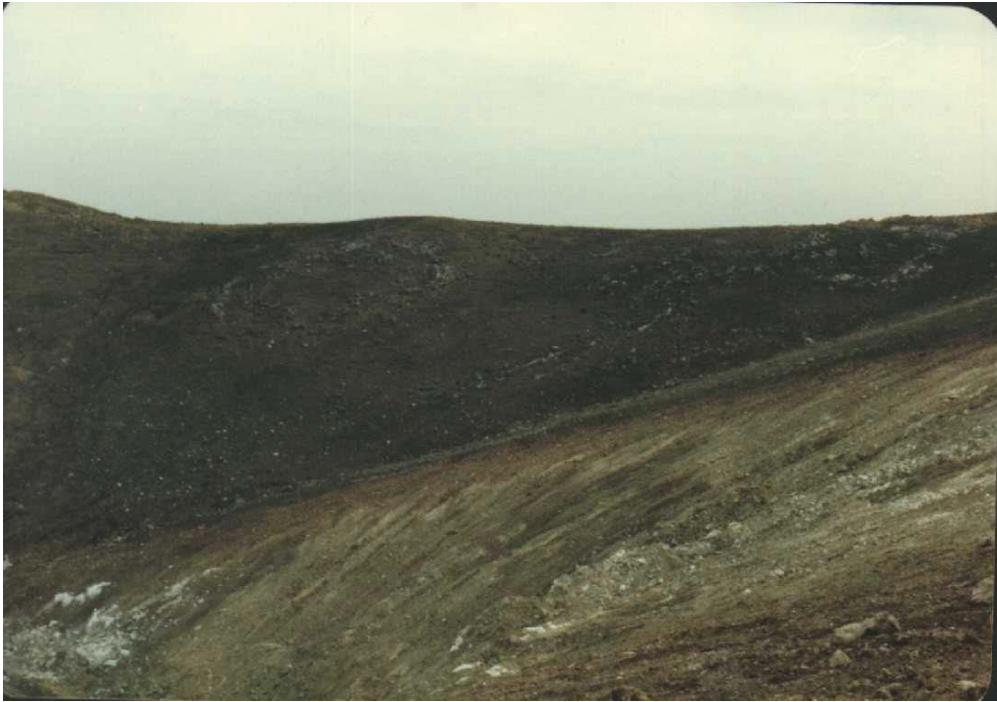
Fig. 1 : Circular ring form in limestone beds

- **Concentric forms** (Figs 1&2). These are formed by layers of different rock types (green marl, red claystone and limestone) in concentric nature, giving them a ring form. The youngest rock being in the center of the ring.  
The diameter of these rings ranges from few meters up to 30m. They were formed due to continuous dissolving of the gypsum and continuous bending of other rocks towards the centre of the depression formed as a result of dissolution. This phenomenon was confirmed from recognizing the rocks along the banks of the site, formed after excavation of rocks for leveling purposes. The height of the banks reached up to 35m.

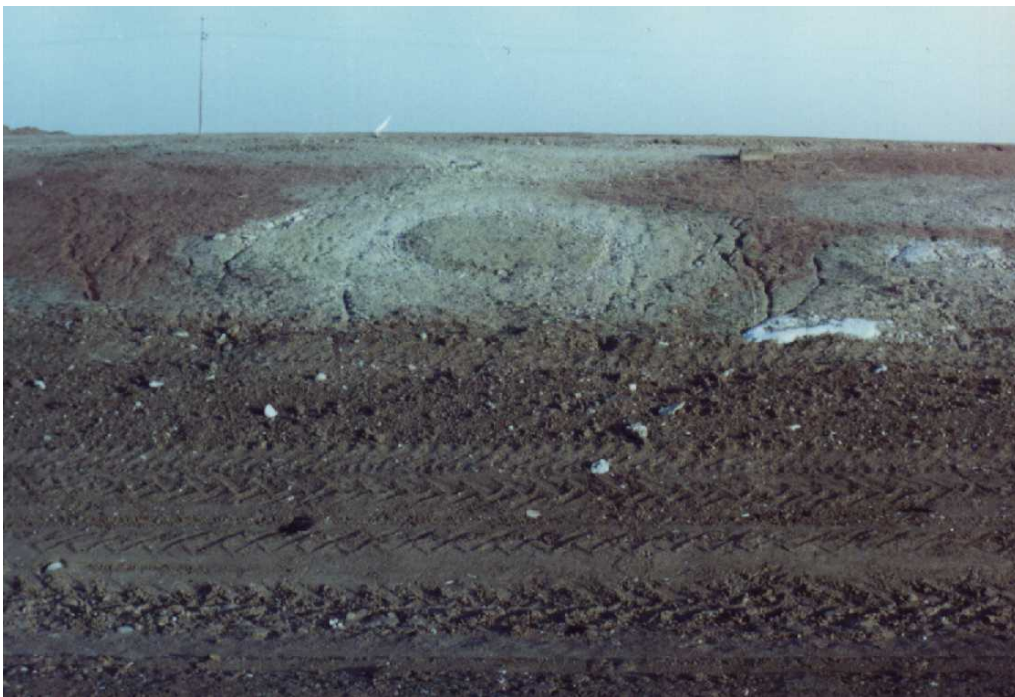
Fig. 2 : Excavated section of the above feature

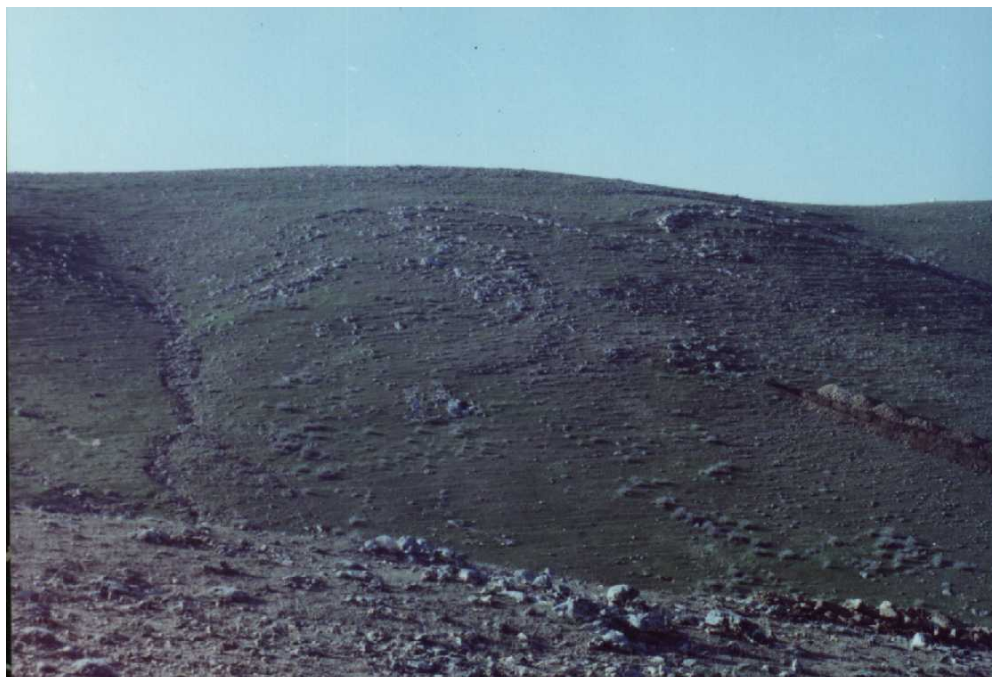
Fig. 3: Limestone beds dis-obeying the V-rule.

- **Disturbed limestone layers.** In normal cases any folded layer will obey the V-rule (Billings, 1964) when crosses a valley (Figs. 3 & 4). In the surroundings of the site many disturbed limestone layers were observed. They were not following the V-rule when crossing a valley. Instead of that different strange forms were developed, which are not structurally controlled. The only explanation for these abnormal disturbed limestone layers is the presence of subsurface karst features beneath them. This was also confirmed from recognizing the rocks along the banks of the site.

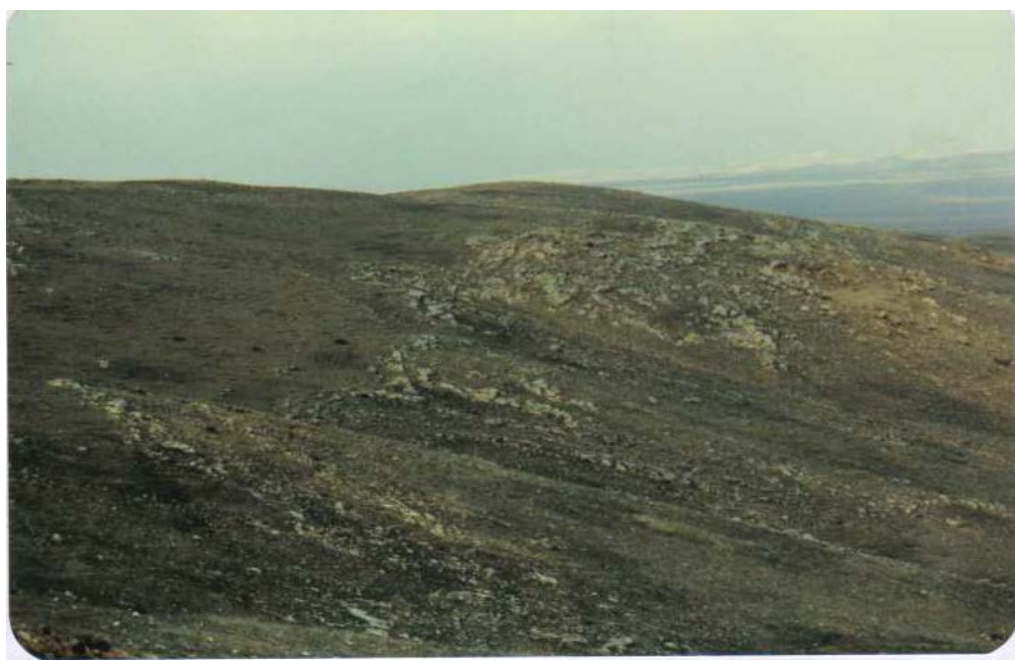
Fig. 4: Limestone beds forming zig-zag and rectangular forms

- **Rectangular forms.** In many places, surrounding the site, limestone horizons were observed to form rectangular and/or zigzag forms (Fig. 4). Usually with very steep inclination towards the center of the rectangular form. The only explanation for these forms is the presence of a subsurface karst feature beneath them. The acute or vertical bending of the beds is attributed to the presence of two sets of joint (almost perpendicular to each other) or small faults. Unfortunately, no opportunity was found to confirm this assumption, because their subsurface extension was not present at the banks of the site.

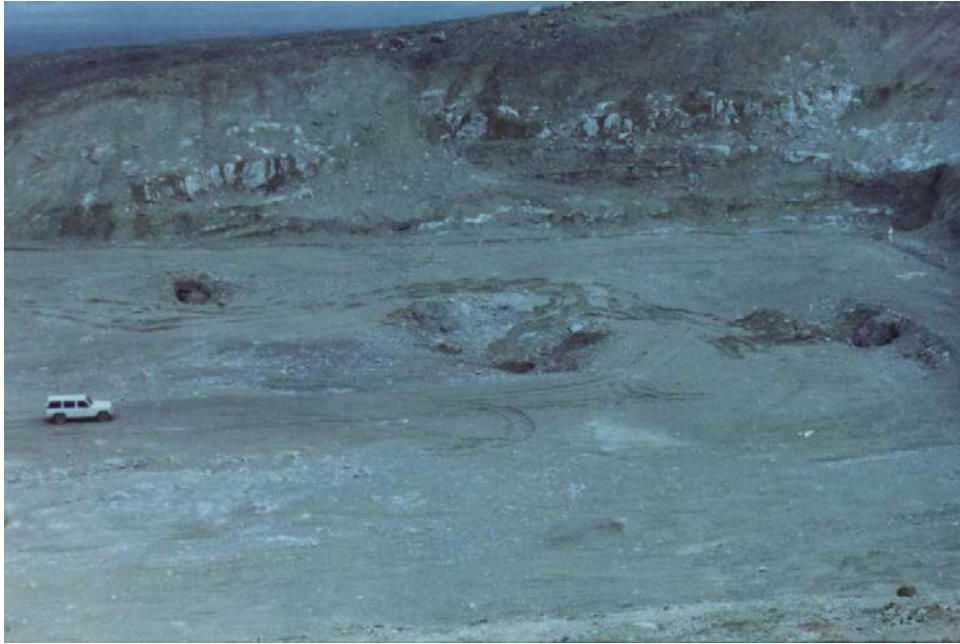
Fig. 5: Karstified gypsum. Note the absence of the gypsum in certain areas and the ring form on the upper right corner (on the surface)

According to the first state contractor, the site was considered to be in a good condition, they have not detected the subsurface karst features, which were almost filled by inhomogeneous materials. Moreover, the absence of gypsum beds (Figs. 5&6) in the extracted core from drilling of nine boreholes, encouraged such evaluation of the site.

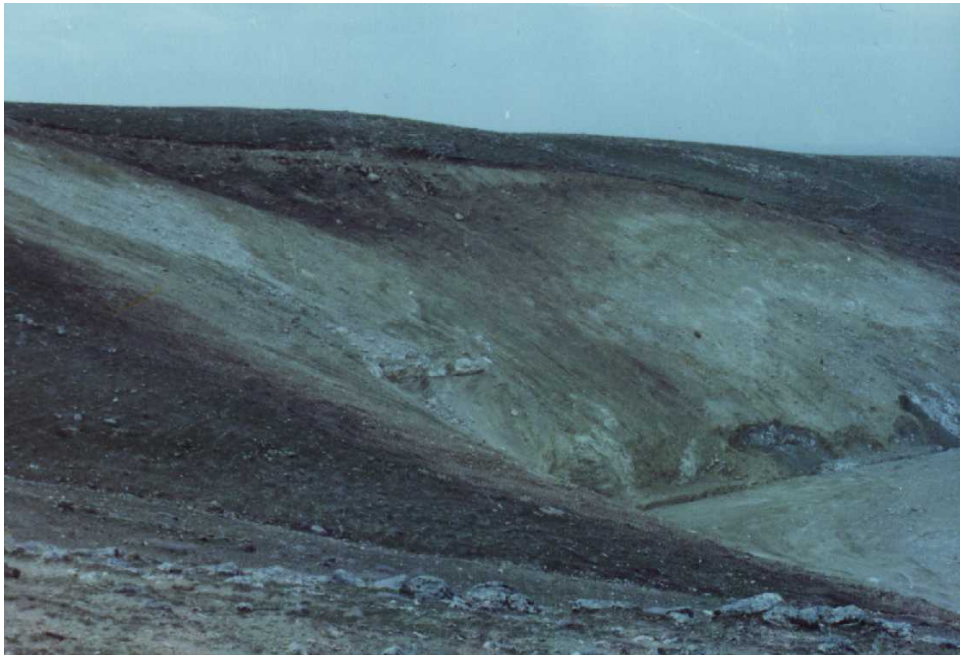
Fig. 6: Large karst, in the floor of the centre of the main site.

Ignoring of the aforementioned two important factors and non-reporting them caused true problem to the site designer (personal communication with the Yugoslavian team, 1987). This was discovered only after extraction of huge amounts of rocks for leveling purpose of the site (Fig. 6).
