## STABILITY ANALYSIS OF A ROAD CUT SLOPES IN AZMUR MOUNTAIN, NORTHEAST IRAQ

Azhar A. G. Al-Khateeb\* and Arsen O. Kapigian\*

### ABSTRACT

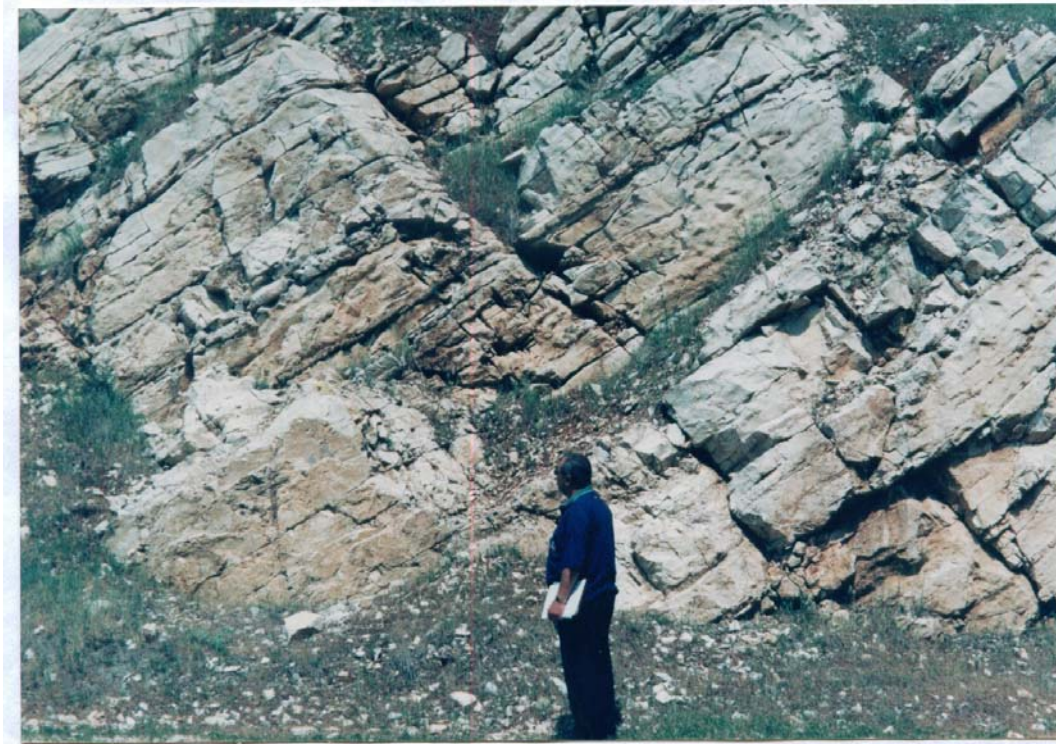
Fig. 3: Station No.(1)

**Station No. (1):** It is located about 3.0 Km from the Police station (Fig.2). Upper part of Kometan Formation is exposed in this station, which consists of well bedded, grey color, fine crystalline, hard, highly jointed limestone. It forms steep scarp inclined 85° towards the east, discontinuity surfaces are planner, rough and filled by clay. Two set of joints were noticed, the first is of NE – SW direction, while the second is of NW – SE direction (Fig.3 and Table 1).

The samples are characterized by rough joint surfaces, slightly to moderately weathered, with little or no filling materials, aperture of the joints is 20 mm near the surfaces and almost zero inside the rock mass. Stereographic projection (Figs.8 and 9) of the discontinuities shows that the probable sliding is of planner type along secondary joint planes ( $J_1$ ), which forms the slope. From the aforementioned data, it is obvious that the slopes in the station seem to be stable, mainly due to roughness of joint planes and relatively slight weathering degree. However according to Hoek and Bray (1977) the most probable movements are sliding and toppling because the probable sliding plane is dipping about 84° SE.

- Station No. (1): As the slope is recently exposed, no remarkable slide have been seen in the field except some upslope blocks, which are susceptible to fall down slope, in future.

- Using in situ shear test in order to get representative value of shear strength parameters besides the effects of roughness, undulation, irregularities and filling materials on shear strength.
- Removing the upslope blocks, which are in critical position and liable to fall in future, especially in station No.(1).
- Retaining walls seem to be the more perfect remedial procedure in station No.(2).

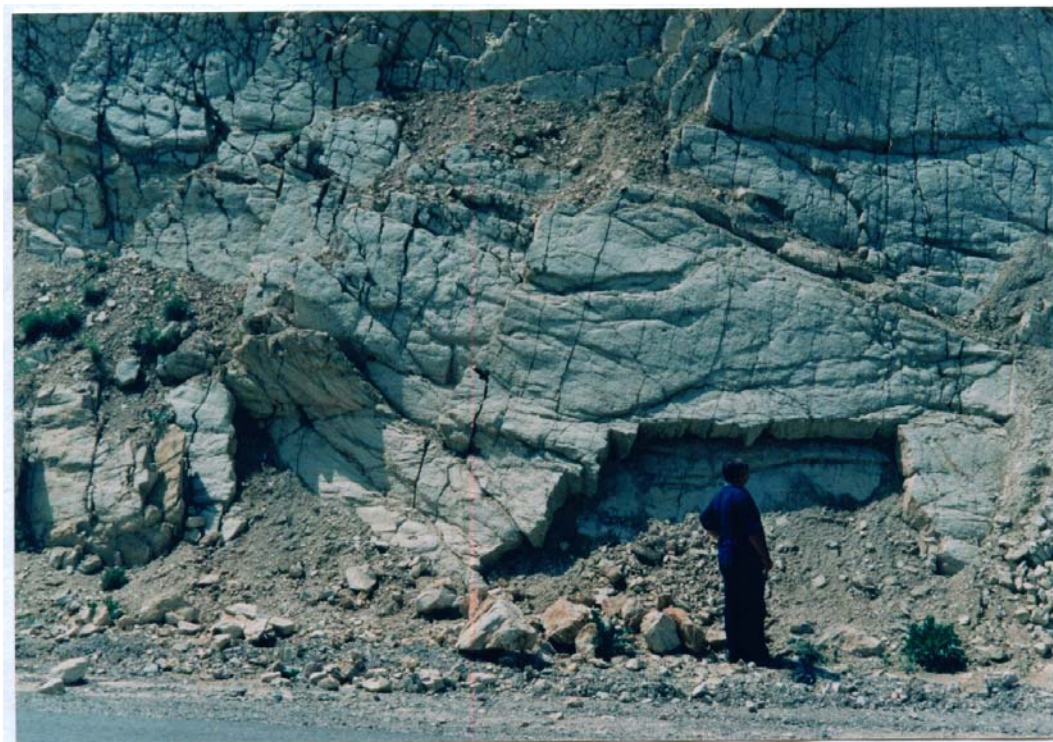
Fig. 4: Station No.(2)

**Station No. (2):** It is located about 1 Km from the Police station (Fig.2) on the northeastern limb of Azmur anticline. The exposed formation is Balambo, which consists of alternation of ammonitiferous marly limestone, and green, soft marl of thickness ranging from (1.0 – 5.0) cm (Ma'ala *et al.*, 2004). There are numerous fallen limestone blocks in front of the slope toe, over a total front of more than 100 m. It is obvious that the rock mass failed in kind of planner slide. Two sets of joints were observed in this locality, the first one is of NE – SW direction and the second is of NW – SE direction (Fig. 4 and Table 1).

It is characterized by planner and smooth joint surfaces, including bedding planes, moderately weathered with thin interbedded green marl of thickness not exceeding few centimeters. Stereographic projection (Figs.8 and 9) of the discontinuities shows that sliding along bedding planes is the most probable case, which is very obvious in the field.

Due to the aforementioned data, beside the high dip amount (72° NE) of the bedding planes towards the probable sliding directions and relatively low value of ( $\varphi_p$ ) with considerable low value of residual friction angle, the station is considered as highly unstable. (Figs. 7 and 8).

- Partial failure of the down slope in station No.(2) makes the rock beds at the upslope in a critical position, (Fig.4).
- High dip amount of sliding plane for stations No.(1 and 2), ( $85^\circ$  and  $72^\circ$ , respectively) is much higher than their corresponding values of internal friction angles ( $\phi_p$ ) ( $35^\circ$  and  $29^\circ$ ) and in this case the planner sliding is more possible.
