SLOPE STABILITY ASSESSMENT WITHIN AND AROUND THE RESERVOIR OF THE PROPOSED BASARA DAM, SULAIMANIYAH, NE IRAQ

Ghafor A. Hamasur¹

ABSTRACT

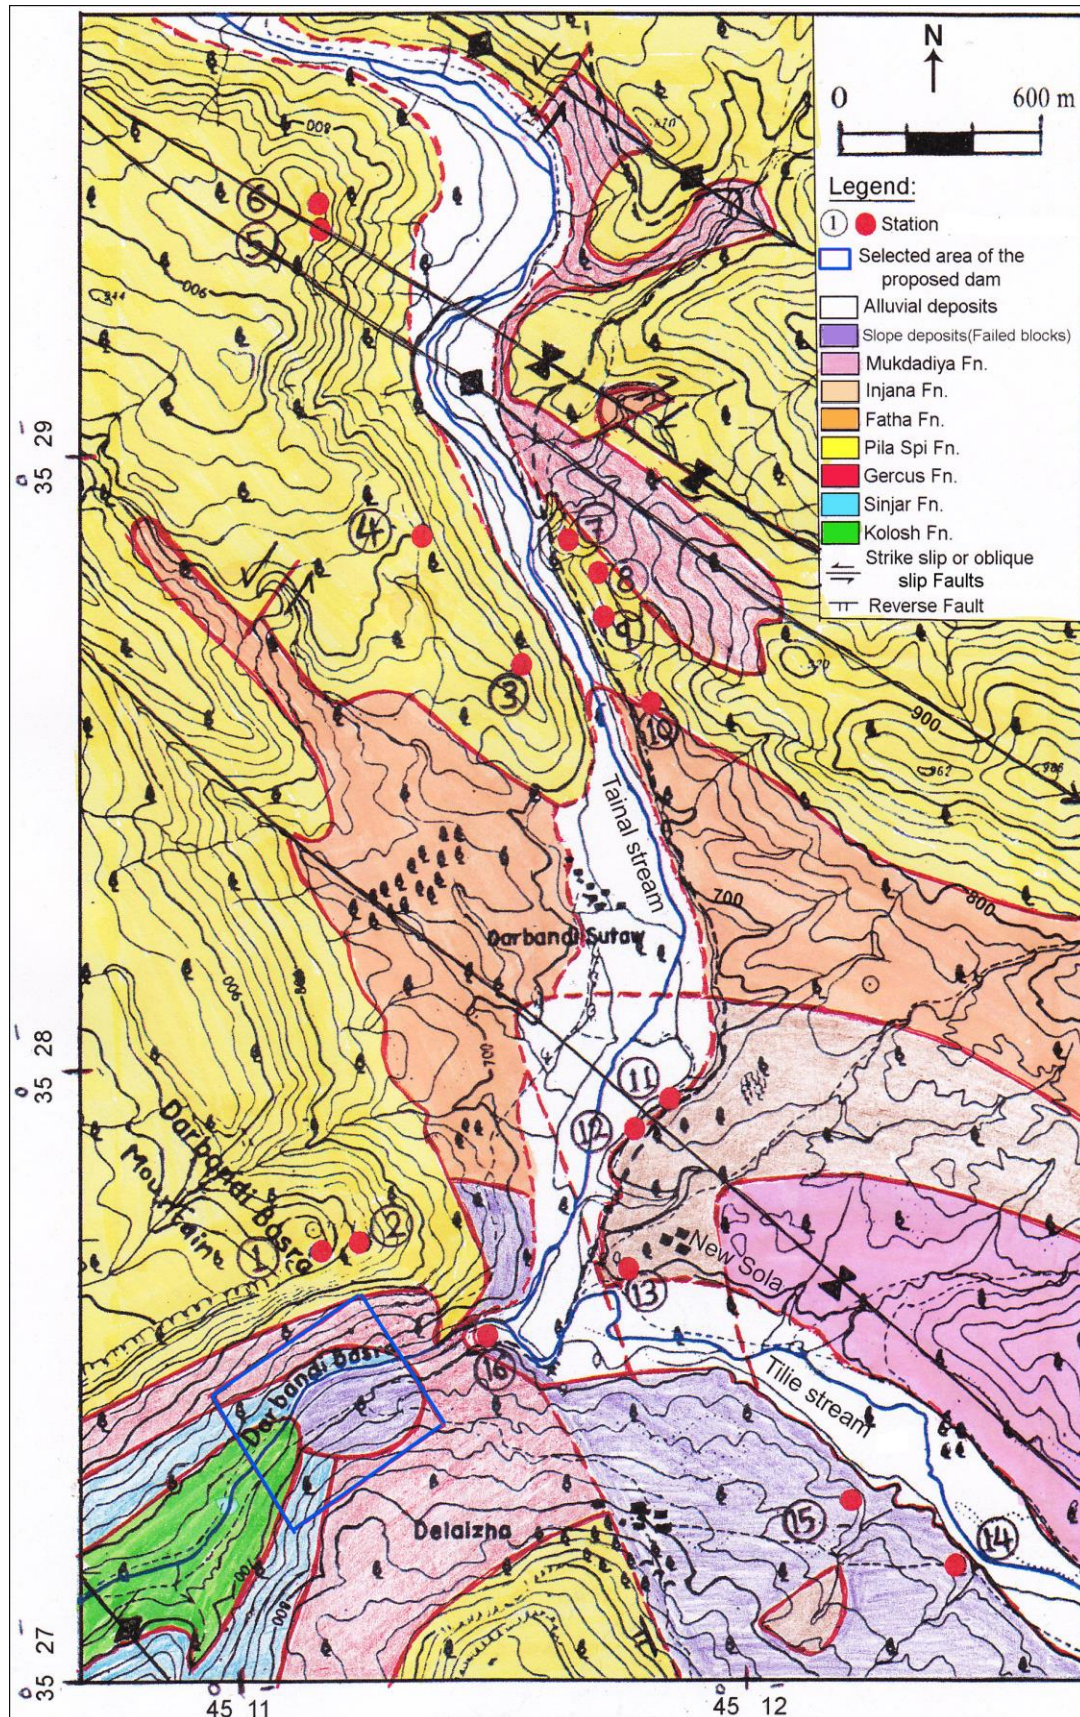
In this study, 14 stations in rock slopes (Stations No. 1, 2, 3, 4, 5, 6, 7, 8, 9, 10, 11, 12, 13 and 15) were selected; within and in the vicinity of the reservoir area. Moreover, 2 stations (Stations No. 14 and 16) in the soil and talus sediments were selected (Fig.2). The possibility of landslide occurrence within the 14 mentioned rock slopes was evaluated; by using the Landslide Possibility Index (LPI) system (Bejerman, 1994), who evaluated rock slopes stability of 2831 m of road, near Los Molinos dam (Cordoba, Argentina) (Bejerman, 1998). This system uses rating, which establishes the failure possibility and to indicate the need for a detailed study. Further study was carried out for those stations, which need a detailed study to determine the type of failure using Hoek and Bray (1981) method.

Fig.2: Geological map shows locations of the studied assessed slopes (stations with serial numbers) (Modified from Hamasur, 2009)
